## ENERGY EFFICIENT ENGINE

### HIGH PRESSURE TURBINE THERMAL BARRIER COATING SUPPORT TECHNOLOGY REPORT

E.C. Duderstadt and P. Agarwal

GENERAL ELECTRIC COMPANY

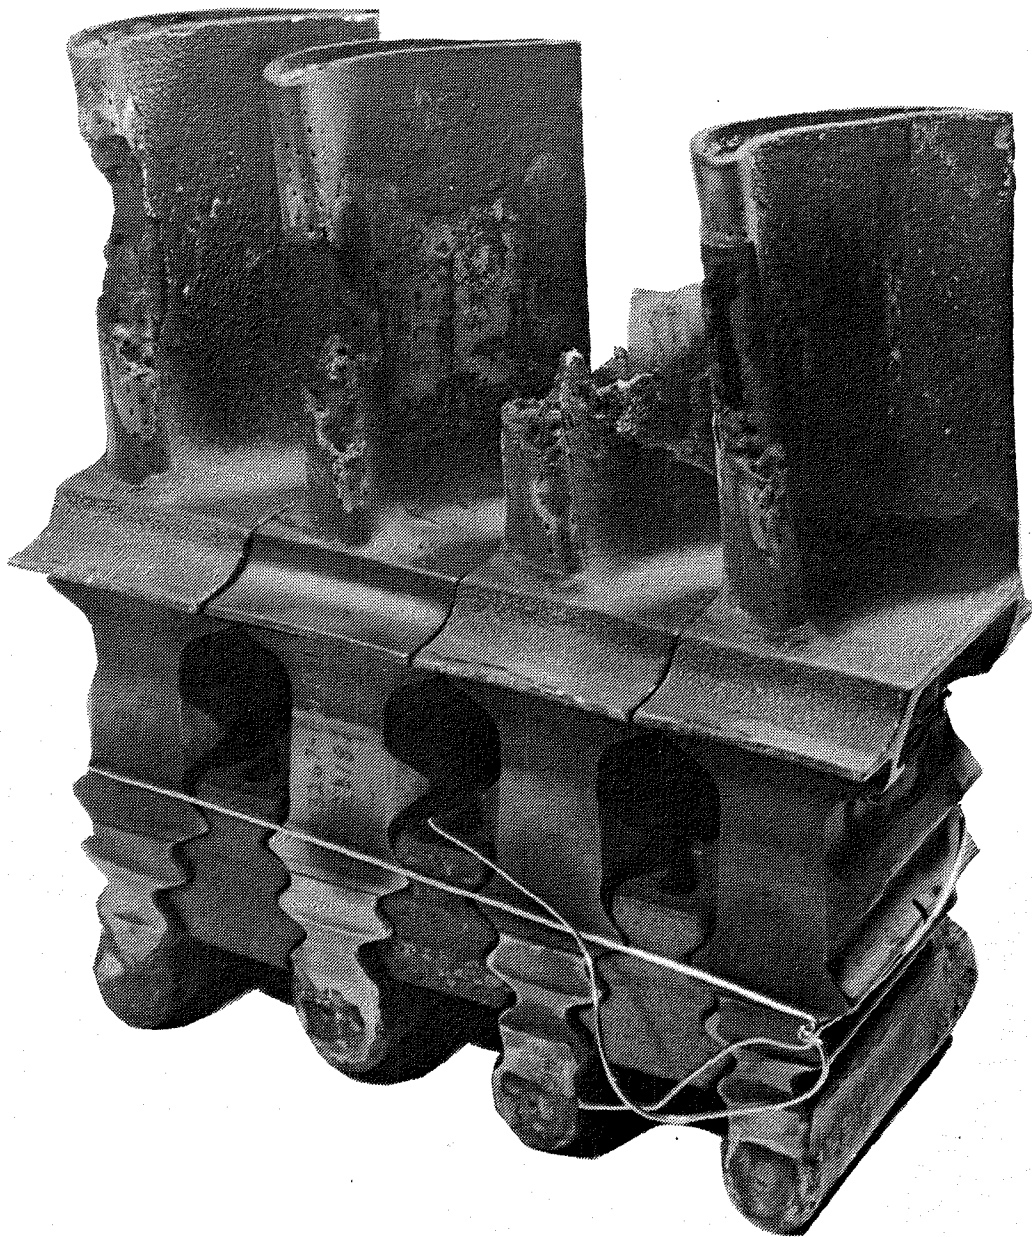
Figure 36. Failed Blades After 390 Cycles of Cascade Rig Testing.

NOTE: The cooling air supply line to the third blade from the left failed after 390 cycles.

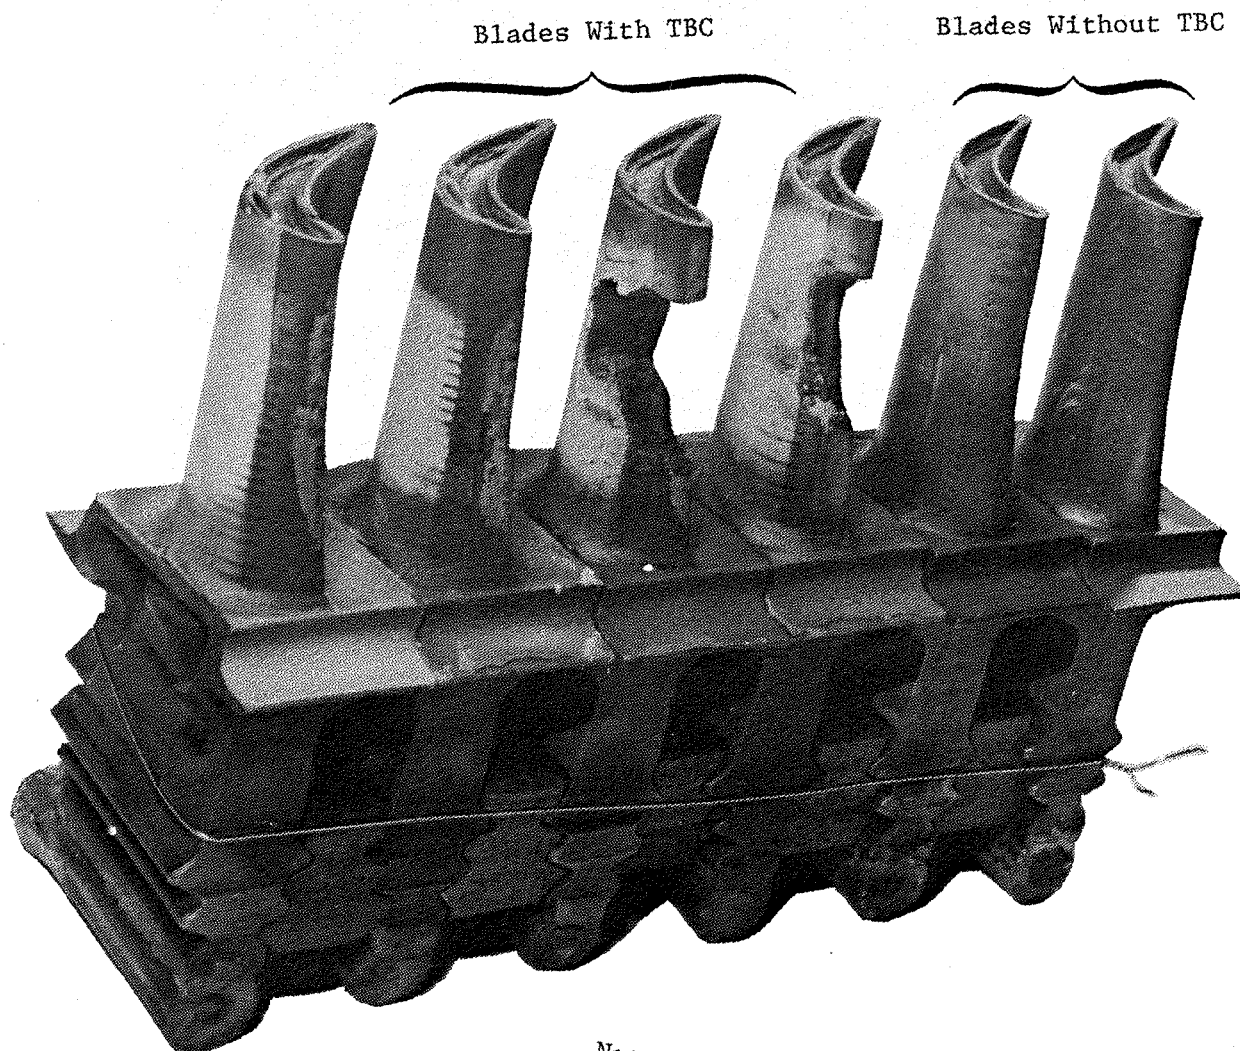
Figure 37. Cascade Rig Test Blades After Termination of  
Test (605 Cycles).

Note: The leading edge burnout  
was caused by a negative  
backflow margin.

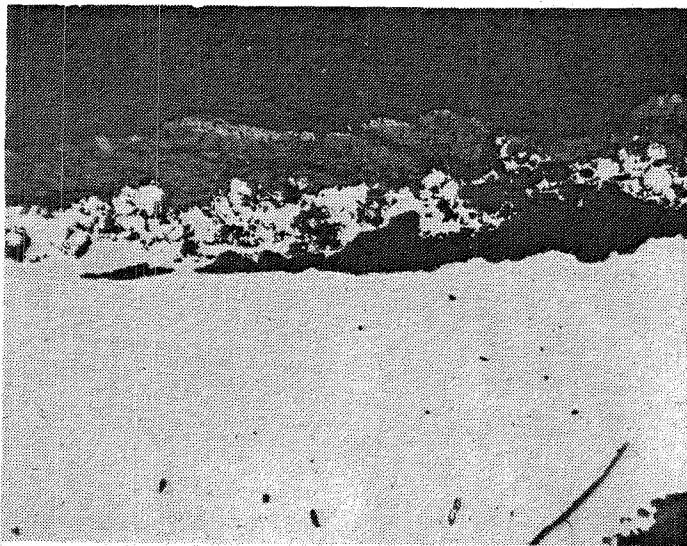
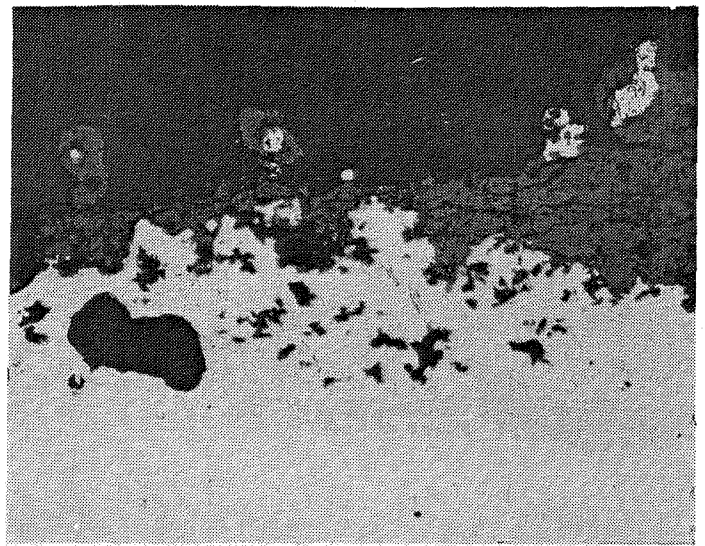
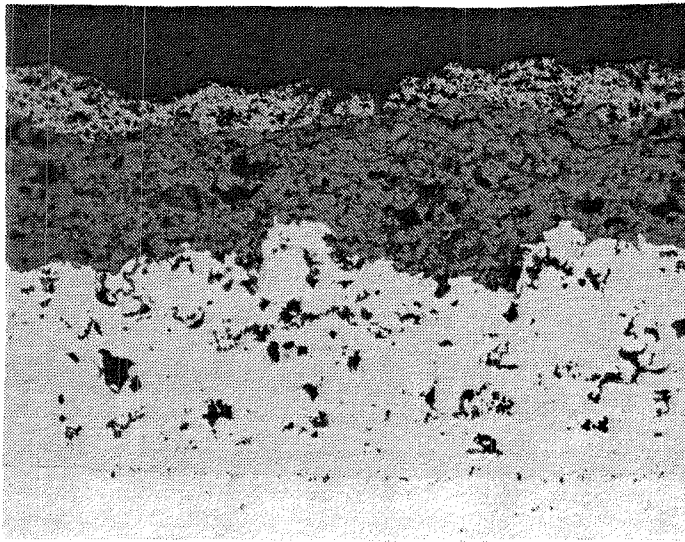
(a) Near Leading Edge in the Damaged Region 200 $\mu$

(b) Near Leading Edge in the Damaged Region 100 $\mu$

(c) Tip Region, Pressure Side 100 $\mu$

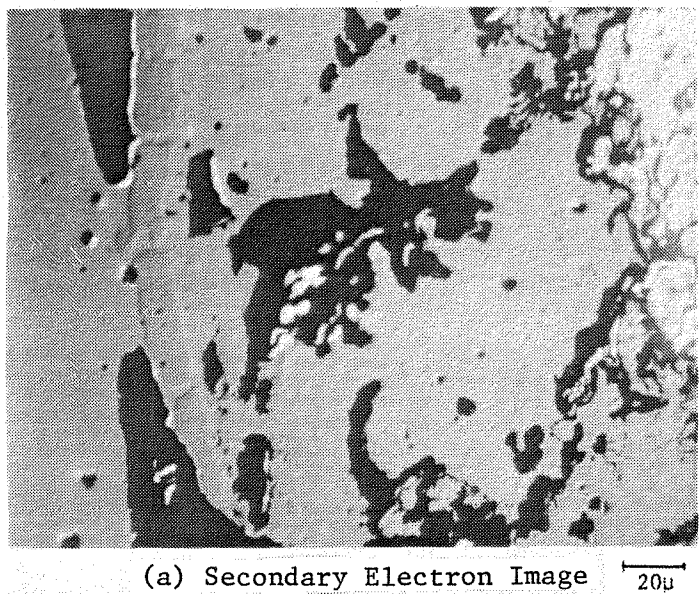
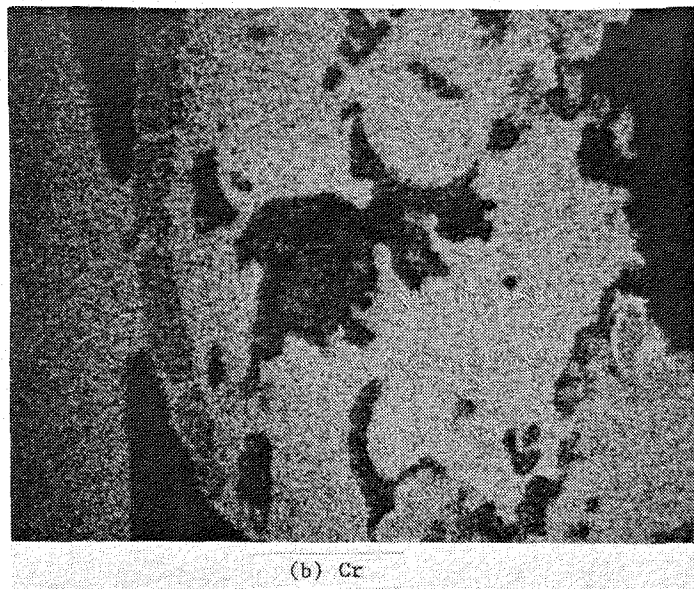
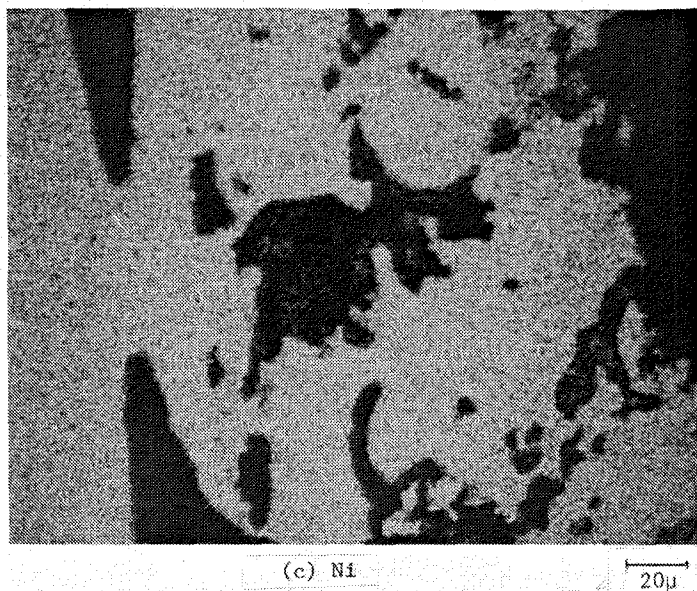
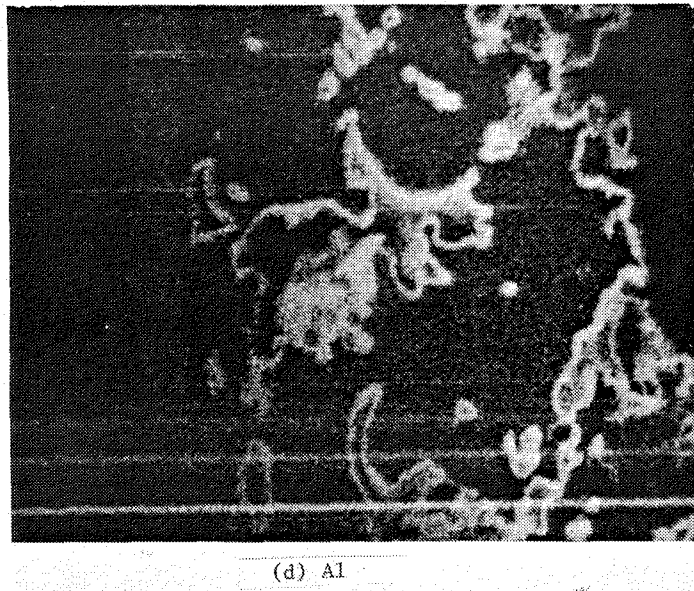
Microprobe examination showed strong aluminum depletion from the bond coat and from the EA Ni-Cr-Al-Hf environmental coating in the region near the leading edge where local melting had occurred. Also noted in this region was the homogenization of the nickel content in the bond coat, environmental coating, and the DS René 150 substrate. Figure 39 shows the secondary electron image and the elemental X-ray density maps in this region. In a region which had experienced lower temperatures during the test (trailing edge and suction side), the above-mentioned changes did not take place. Coatings retained their original or close to original chemical compositions as shown in Figure 40.

Figure 39. Secondary Electron Image and Elemental X-ray Density Maps of Thermal-Barrier-Coated, CF6-50, Stage 1 HPT Blade (No. 0395) Near the Damaged Region After 390 Cycles of Cascade Rig Testing.

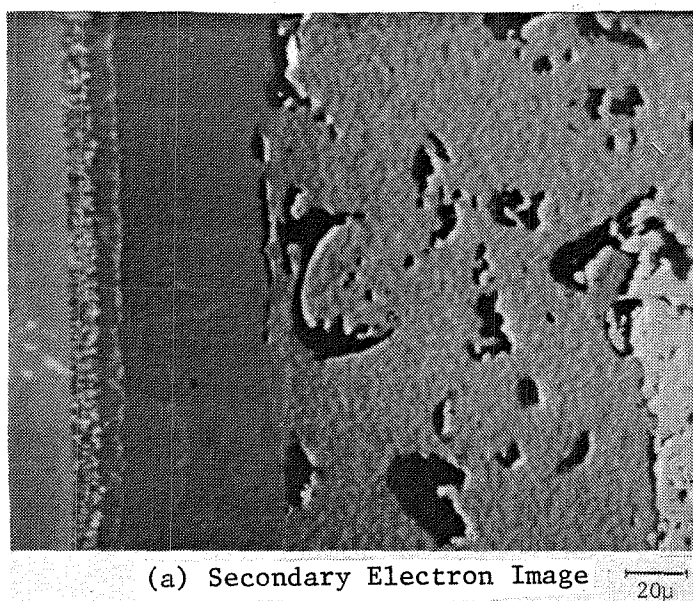
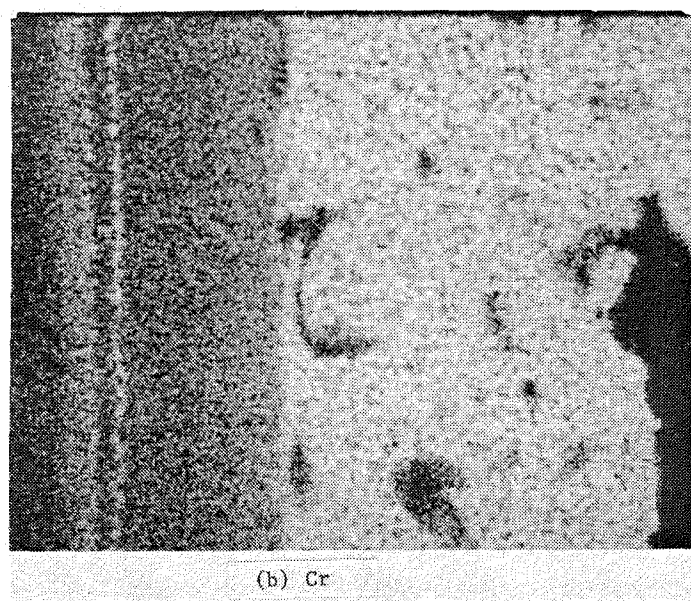
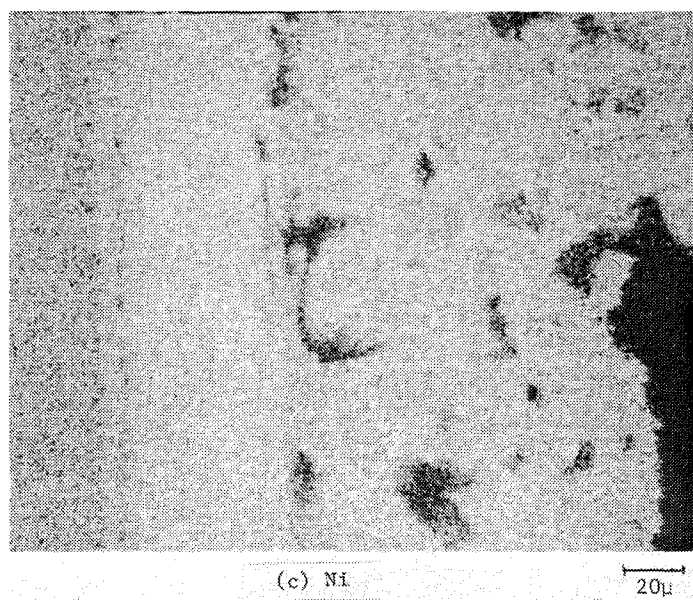
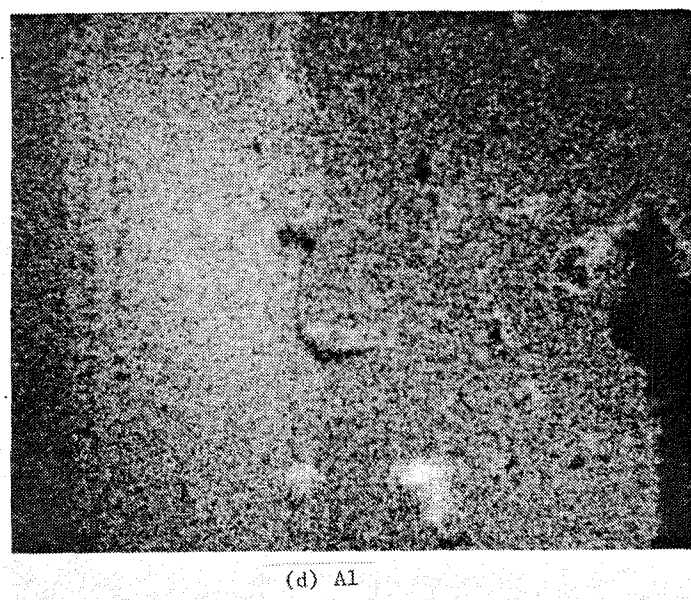
Figure 40. Secondary Electron Image and Elemental X-ray Density Maps of Thermal-Barrier-Coated, CF6-50, Stage 1 HPT Blade (No. 0395) Near Trailing Edge After 390 Cycles of Cascade Rig Testing.

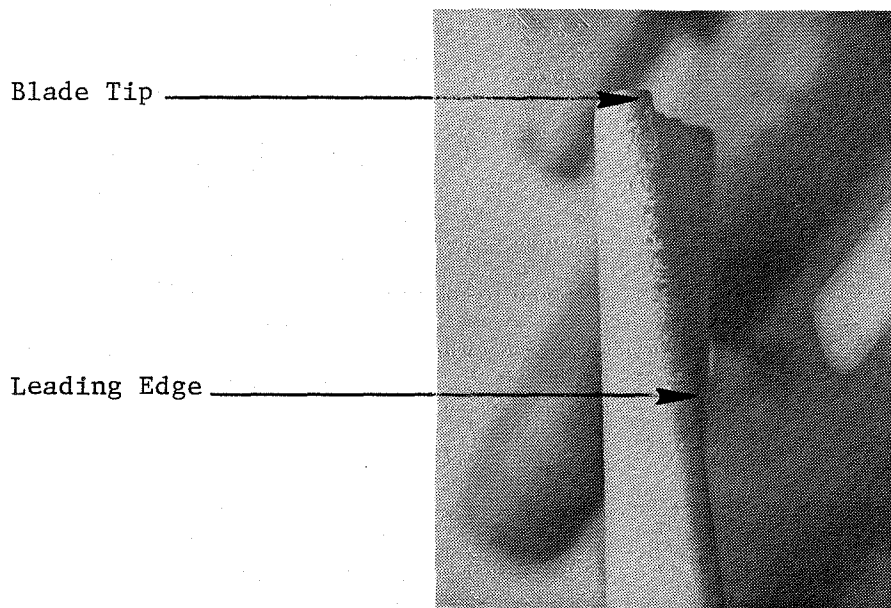
Figure 44. Photograph Showing Damage to Leading Edge of Thermal-Barrier-Coated Blade After 16 Hours of Engine Checkout.

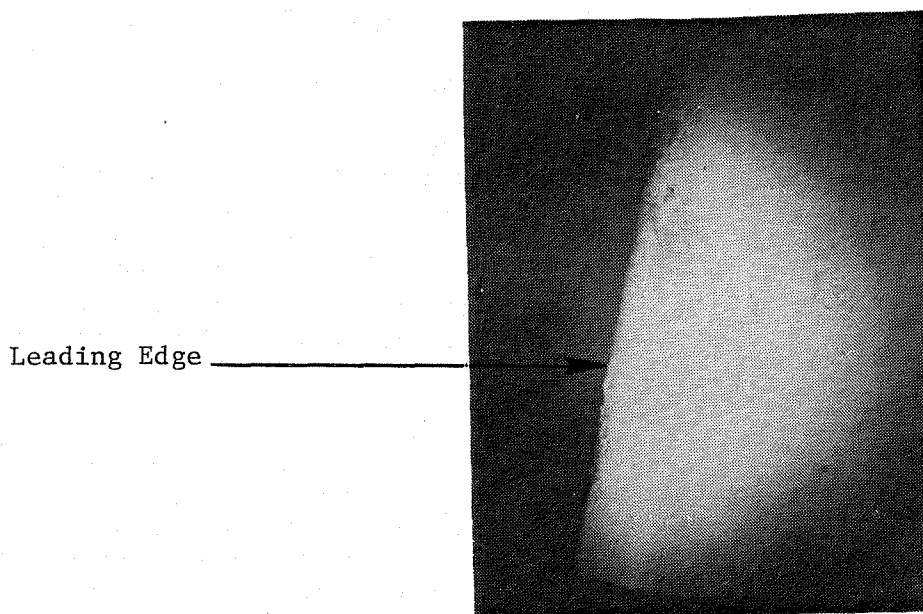
Figure 45. Borescope Photograph Showing Extent of Damage to Leading Edge of Thermal-Barrier-Coated Blade After 476 "C" Cycles.

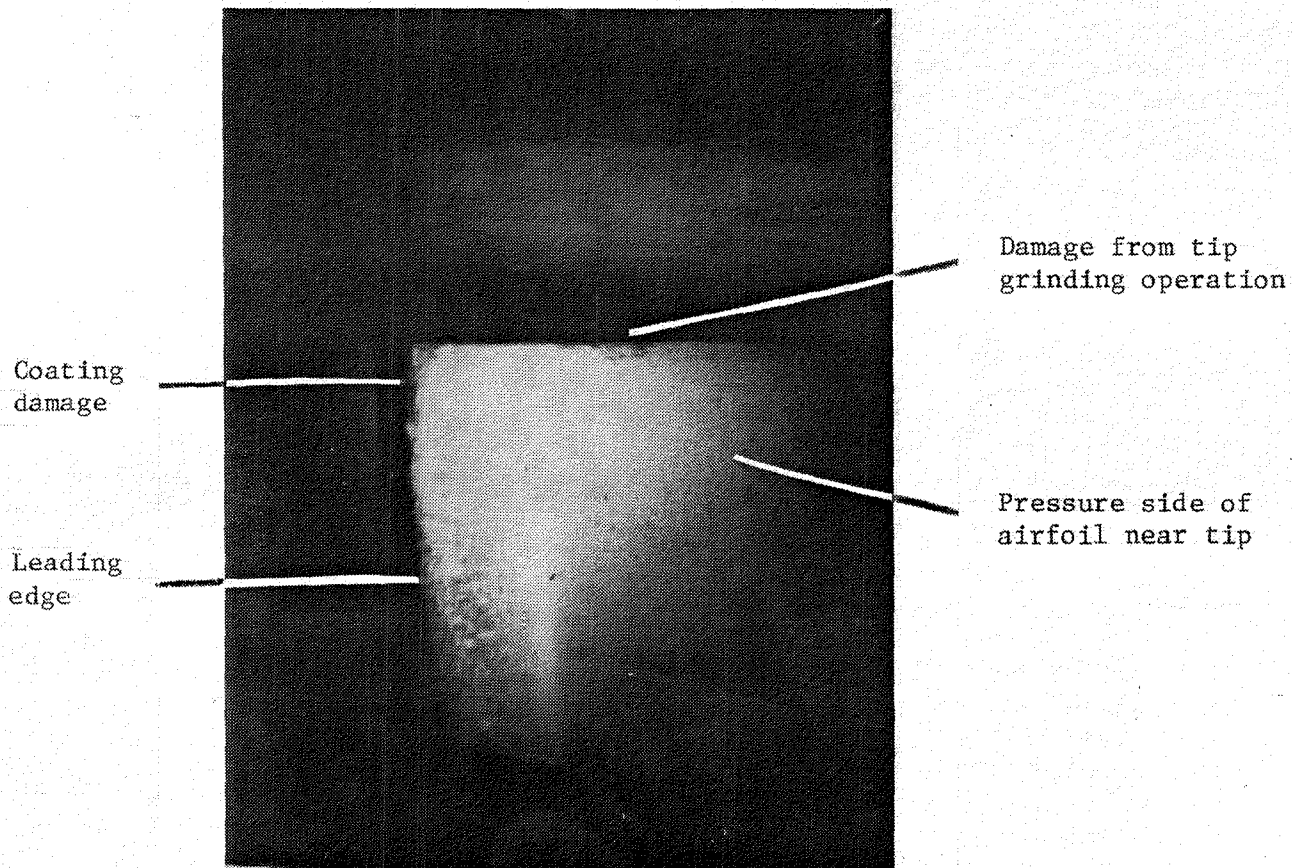
Figure 46. Borescope Photograph of Coating Damage After 27 Hours of Engine Checkout (Blade A2139).

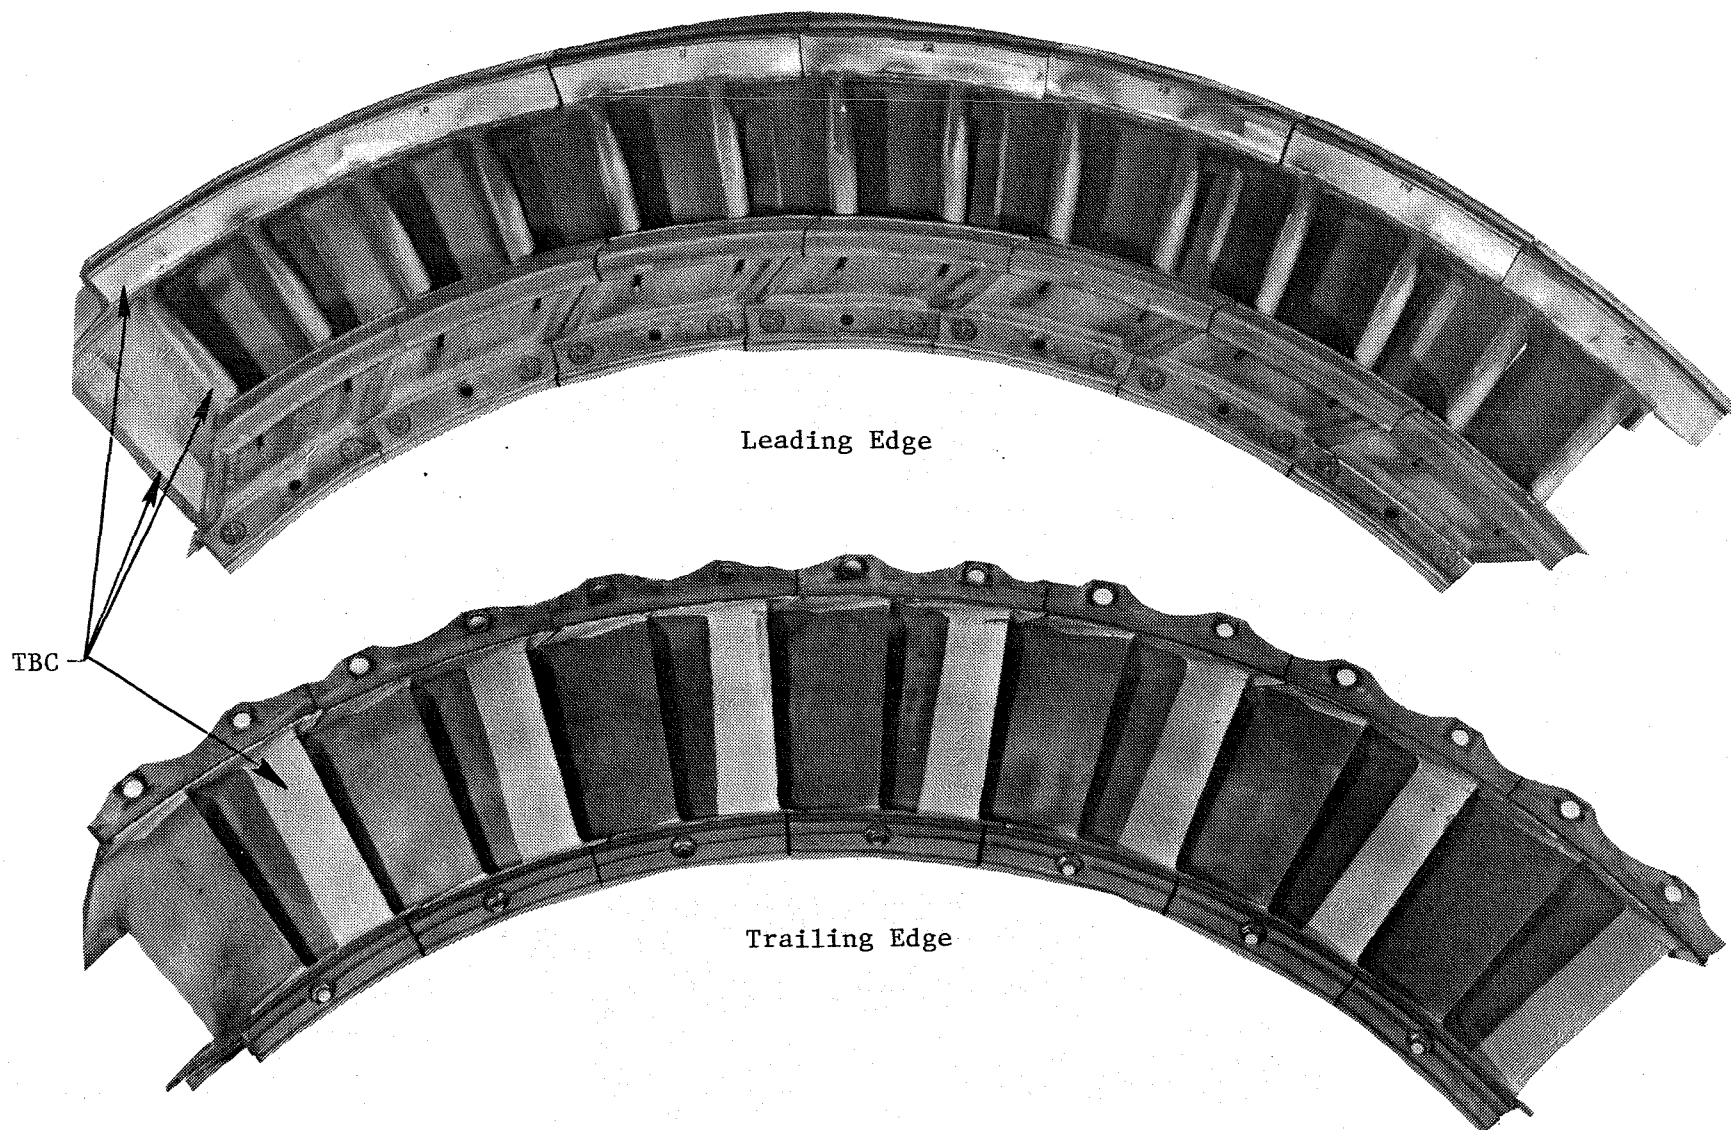
Some coating loss occurred from the outer 1/3 to 2/3 of the airfoil leading edge of every thermal-barrier-coated Stage 2 vane. The abrupt edge of the remaining coating suggests that coating loss was by spalling rather than from impact by particulate matter. In localized areas of the outer band near the leading edge of some of the airfoils, the ceramic layer was missing after 1000 endurance cycles and appeared to have been eroded away by particle impingement. The TBC was in good condition on the other areas of the vanes. The bond coat layer on the vanes was oxidized to a much greater extent than it was on the blades. Variation in coating thickness was much greater on the vanes than on the blades, indicating that further improvements are needed in the application process for coating vanes. The Stage 1 vanes remained in the engine for further testing and were not available for analysis.

Figure 55. Thermal-Barrier-Coated, CF6-50, Stage 2 Vanes After Factory Engine Test of 1000 "C" Cycles.

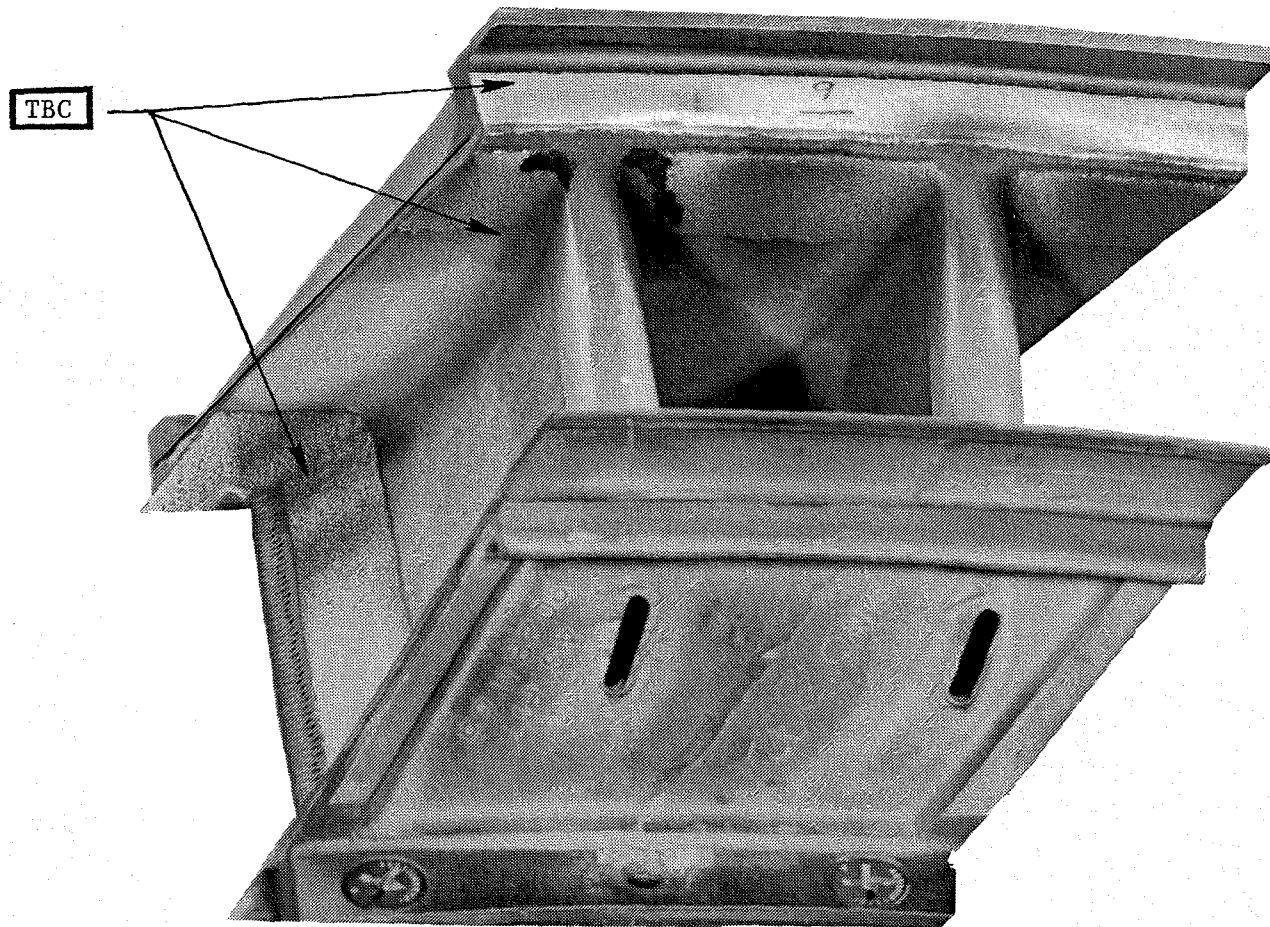
Figure 56. Thermal-Barrier-Coated, CF6-50 Stage 2 Vane After 1000 "C" Cycle Factory Engine Test.
